Development of a field repair technique for mini-sandwich Kevlar/epoxy aircraft skin.

THESIS

DEVELOPMENT OF A FIELD REPAIR TECHNIQUE
FOR "MINI-SANDWICH" KEVLAR/EPOXY
AIRCRAFT SKIN

June 1984

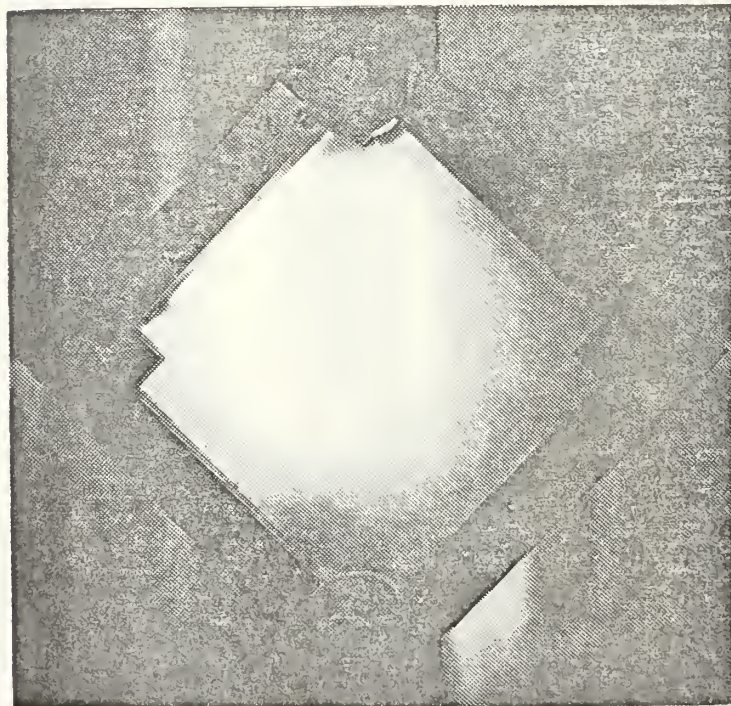
50 Pounds Applied Load

100 Pounds Applied Load

150 Pounds Applied Load

200 Pounds Applied Load

250 Pounds Applied Load

300 Pounds Applied Load

In order to insure that the state of stress developed within the shear fixture was uniform over a large portion of the test area, a test panel composed solely of 0.125 inch thick sheet photoelastic material was prepared and secured in the "picture frame" with 30 inch-pounds of torque applied to the thirty-six through bolts. The photoelastic panel had been prepared by coating one side evenly with a reflective aluminized paint. A polariscope and camera arrangement was used to photograph the resulting stress distribution as exhibited by the photoelastic process. Appendix A contains

photographic results of the stress distribution throughout the load cycle. It can be seen from these results that uniformity of stress in fact did exist across nearly the entire test area at higher loads, with the stress gradients being restricted to the regions immediately surrounding the corners and near the edges.

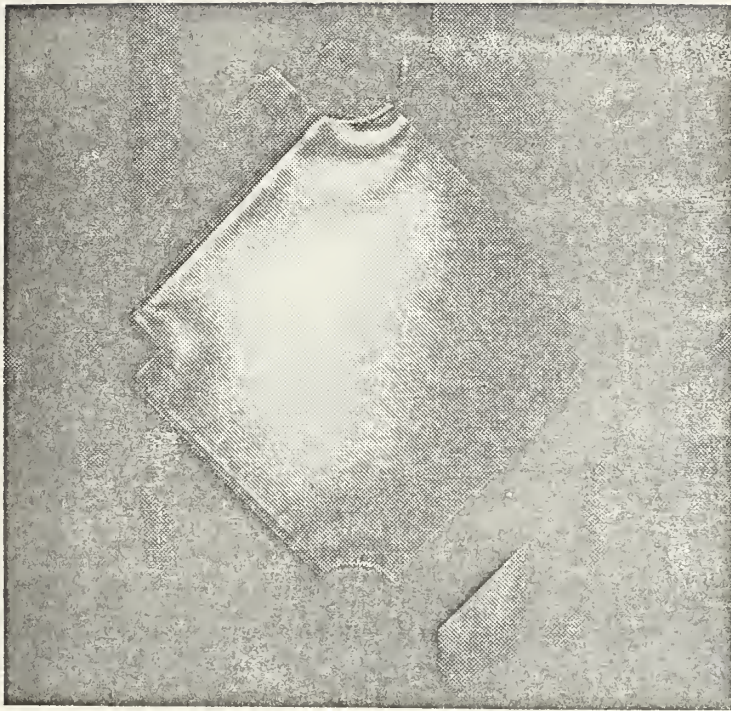
400 Pounds Applied Load

500 Pounds Applied Load

750 Pounds Applied Load

1000 Pounds Applied Load

1400 Pounds Applied Load

1800 Pounds Applied Load
